CLARKDIETRICH BUILDING SYSTEMS, LLC ACOUSTICAL PERFORMANCE TEST REPORT

ASTM E90 SOUND TRANSMISSION LOSS TESTING ON A
UL-U340, STAGGERED CHASE WALL SYSTEM

L3173.21-113-11-R0

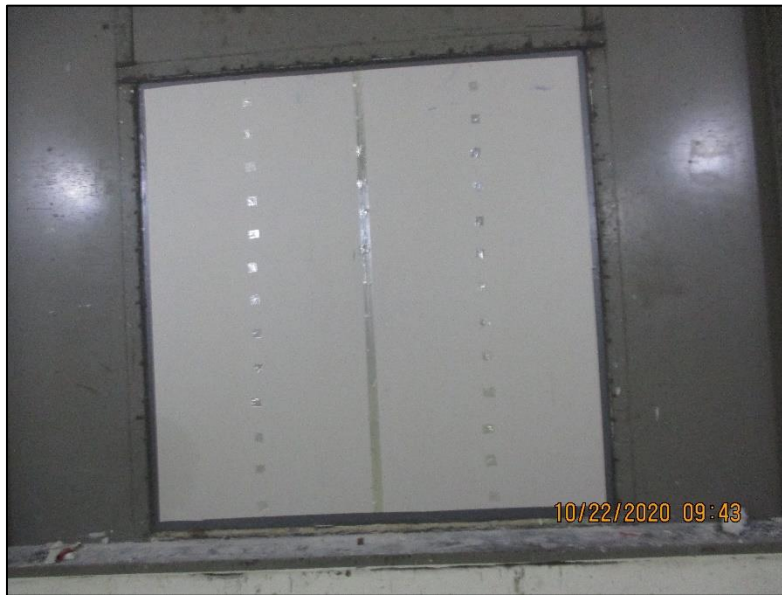
Photo No. 1
Receive Room View of Installed Specimen

Photographs are included in Section 11.

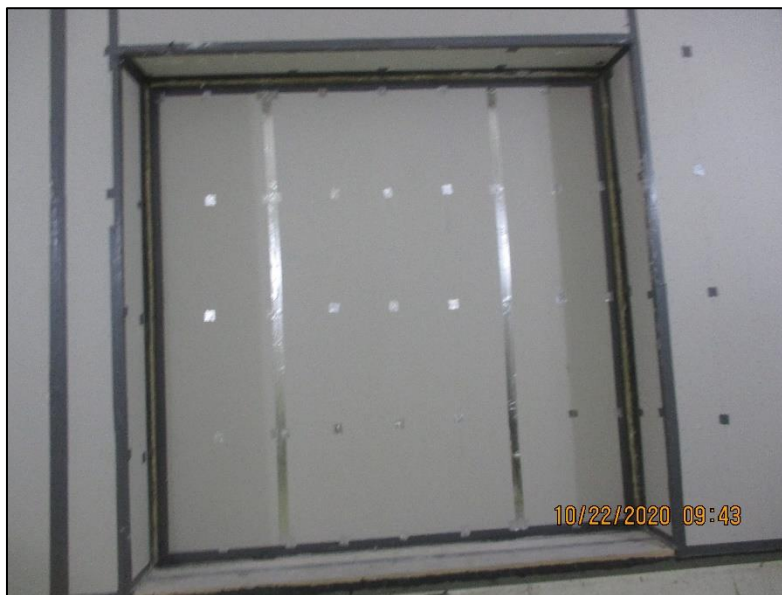
Photo No. 2
Source Room View of Installed Specimen
